R. Heyl & Associates

Inspection Report

123 Sample Drive
Saint Louis MO 00000

Date: 11/26/2010	Time: 11:30 AM	Report ID: 000
Property: 123 Sample Drive Saint Louis MO 00000	Customer: John Q. Public	Real Estate Professional:

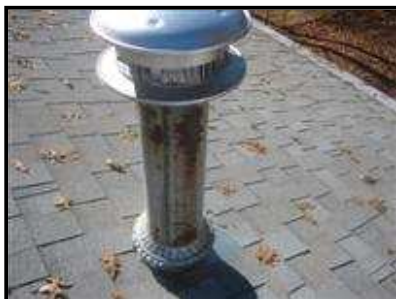
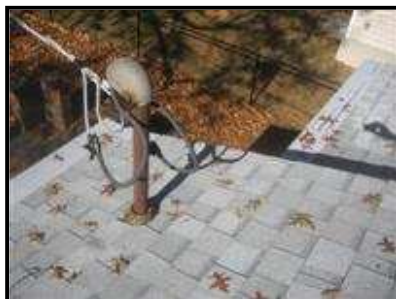
1. Photos 1-2: Paint furnace flue and electrical service mast at roof to stop rust.
2. Caulk driveway joints (photo 3) to minimize seasonal movement. Use of joint filler for improved caulking performance.
3. Photo 4: Caulk window frame perimeters where caulking is missing.
4. Dryer vent cover at exterior wall is stuck open.
5. Hall bath toilet tank flush arm sticks open.

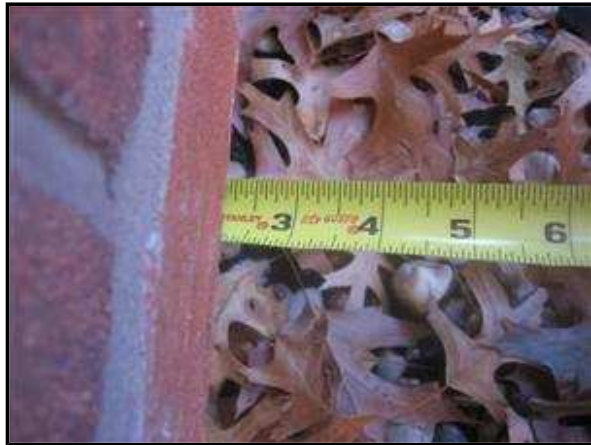
1. Photo 1-2: Rear foundation wall has bowed inward and stabilization repairs are required. Contact reputable foundation repair contractors for suggestions and bids for repair. Stiff-backs or tie backs will probably be recommended. The diagonal cracks in rear foundation wall were caused by lateral pressure of ground and seasonal ground freeze. These cracks will require epoxy injection if ground water seepage ever occurs.

3.0 Picture 1 - Top center of rear basement wall.

The foundation walls are poured in place concrete construction; full basement design. Rear basement foundation wall has bowed inward and needs structural repairs (see commentary in "Notes").

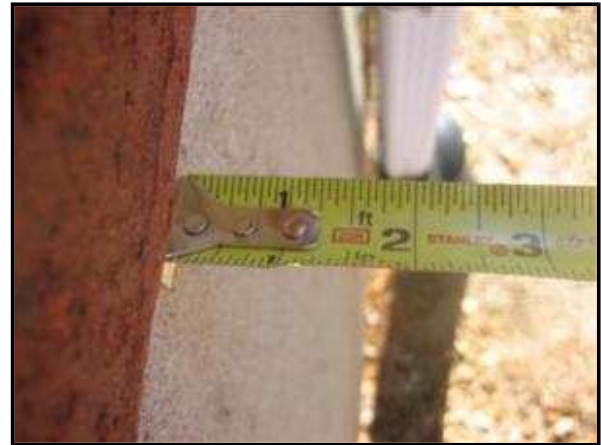
3.0 Picture 2 - Top SW corner of rear wall.

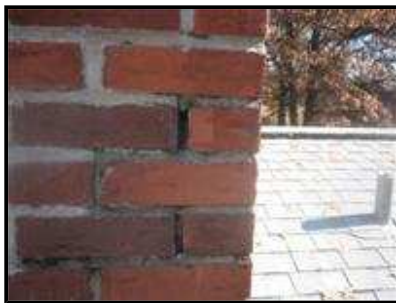
3.0 Picture 3

2. Photo 3: Tuckpoint the eroded mortar joints on the chimney as necessary to prevent water and frost damage
3. Photos 4-5: Sidewalk at north side of garage wall is higher than frame wall base plate and bottom of wall studs. Keep edge of sidewalk sealed with exterior caulk. Bottom of wall will require reframing with treated lumber.

The masonry chimney above roof needs spot tuckpointing. Review chimney, its flashing and top of chimney cap annually. Be sure to tuckpoint on a timely basis when loose or cracked mortar joints are observed. Also caulk or patch chimney cap when cracks are observed and make sure chimney flashing is kept well secured and sealed as needed.

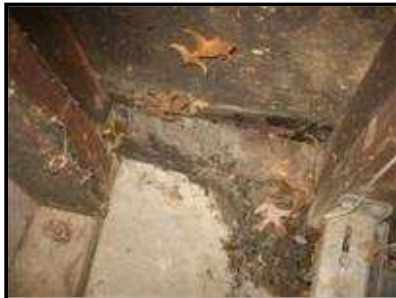
3.0 Picture 6

4. Photo 6: NE corner of garage needs baseplate repair and replacement.
5. Photos 7-8: NE garage corner brick veneer is moving which would indicate the footing is not stable. Short term, recaulking is needed. A definitive repair would require brick veneer wall reconstruction after an appropriate footing is poured in place.

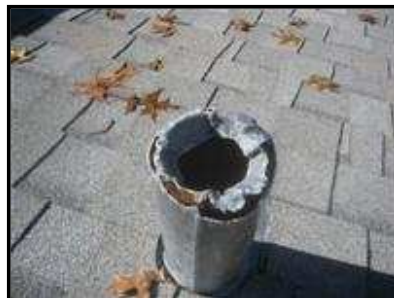
3.0 Picture 9

6. Photo 9: Three plumbing vent pipes at roof need flashing caps to repair deteriorated lead flashing.
7. Photo 10: Protect hall bathroom recessed light fixtures (can lights) in attic with appropriate spacing cover (light cap) so that insulation does not touch can light fixtures. Reference this website for one type of solution: <http://www.tenmat-us.com/thermal-product-ff135.htm>

There were no apparent roof flashing deficiencies at this time except for plumbing vents pipes at roof (see "Notes"). Flashing areas are vulnerable to leaks, therefore, all roof flashing areas should be examined annually so that maintenance and/or repairs can be performed on a timely basis.
