R. Heyl & Associates

Inspection Report

123 Sample Drive
Saint Louis MO 00000

Date: 11/26/2010	Time: 11:30 AM	Report ID: 000
Property: 123 Sample Drive Saint Louis MO 00000	Customer: John Q. Public	Real Estate Professional:

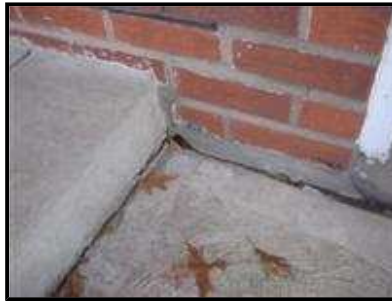
2.0 Picture 3

1. Photos 1-2: Paint furnace flue and electrical service mast at roof to stop rust.
2. Caulk driveway joints (photo 3) to minimize seasonal movement. Use of joint filler for improved caulking performance.
3. Photo 4: Caulk window frame perimeters where caulking is missing.
4. Dryer vent cover at exterior wall is stuck open.
5. Hall bath toilet tank flush arm sticks open.

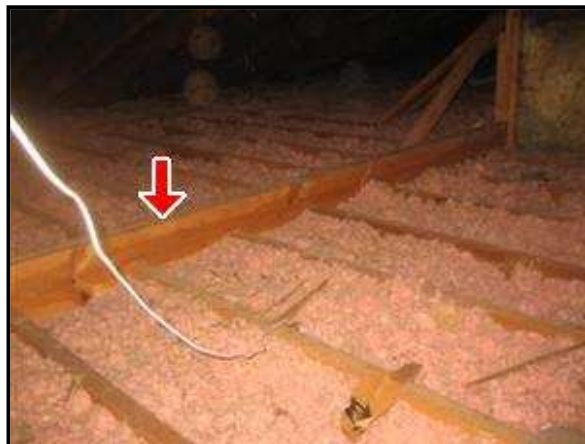
15.0 Picture 1

The interior walls, ceilings and floors were in acceptable condition relative to age with no evidence of unusual movement. Overall cosmetic condition and housekeeping are a subjective determination based on individual standards and this report provides no commentary on this subject. FYI: Minor cracks near doorways, windows, ceilings and corners that exist or might develop are typical for a house of this age and require cosmetic attention only. Living room ceiling crack is due to overhead ceiling joist beam location (photo 1).
